**Flood Control Project Maintenance
Levee Inspections**

Maintenance Issue Types Only, Levee Inspection Report By Mile - Spring 2017

Reclamation District No. 0563 Tyler Island

Waterway	Bank	Unit Miles	Inspection Start/End	Inspector
Unit No. 01 Georgiana Slough (Tyler Island)	Left	12.11	03/14/2017 03/16/2017	Richard Willoughby

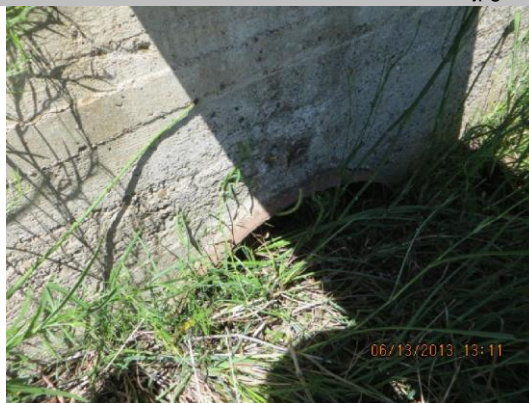
Photo 1 of 2 : UCIP_SP_2017_15028_24736.jpg

LM Start	12.00	Rating **	M	Issue No.	805
LM End	12.00	Issue Type +	Ma	Location *	WS
Category	Supplemental			GPS Latitude/Longitude	
				Start	End
Item	DWR UCIP LMA Responsibility			38.130730 °	38.130730 °
				-121.579616 °	-121.579616 °
DWR ID					
Comment Code					
Inspector Comment					
FS_ID:15028 DS_ID:20182 EP_NO: N/A Repair Type: Non-Urgent Crossing Status: Found UCIP Comments: Verify pipe is properly abandoned. FIELD_STRUCT_DESC: *REMOVED* 1 of 2: 36-inch pipe through the levee 4-feet below the crown. Shut-off valve at pump. Pipe visible on WS at headwall. Originally included in the 1954 O&M manual. Replaced by a 30-inch pipe under Permit No. 2635. FS Date: 6/13/2013

Pipe at concrete headwall on WS slope.

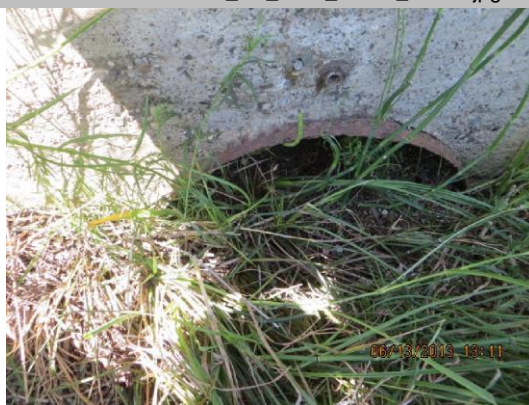
Photo 2 of 2 : UCIP_SP_2017_15028_24735.jpg

Pipe at concrete headwall on WS slope.

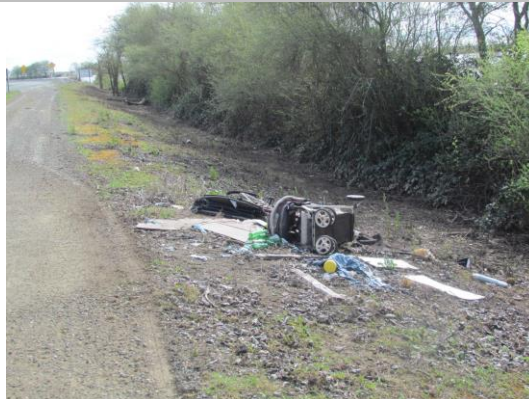
Photo 1 of 1 : SP_2017_RD0563_210_107_20170316_00263.jpg

LM Start	12.03	Rating **	M	Issue No.	107
LM End	12.03	Issue Type +	Ma	Location *	WS
Category	Earthen Levee			GPS Latitude/Longitude	
				Start	End
Item	Encroachments			38.130776 °	38.130776 °
				-121.579063 °	-121.579063 °
DWR ID	DWR_RD0563_01_f_2013_107				
Comment Code					
GA : Garbage					
Inspector Comment					
Garbage on waterward shoulder.

Looking southeast at garbage on waterward shoulder and slope.
